SUBJECT: START 3, EPA Region 8, Contract No. EP-W-05-050, TDD No. 1008-13
Trip Report, Upper Animas Mining District, Silverton, San Juan County, Colorado

TRIP REPORT
Upper Animas Mining District
Silverton, San Juan County, Colorado

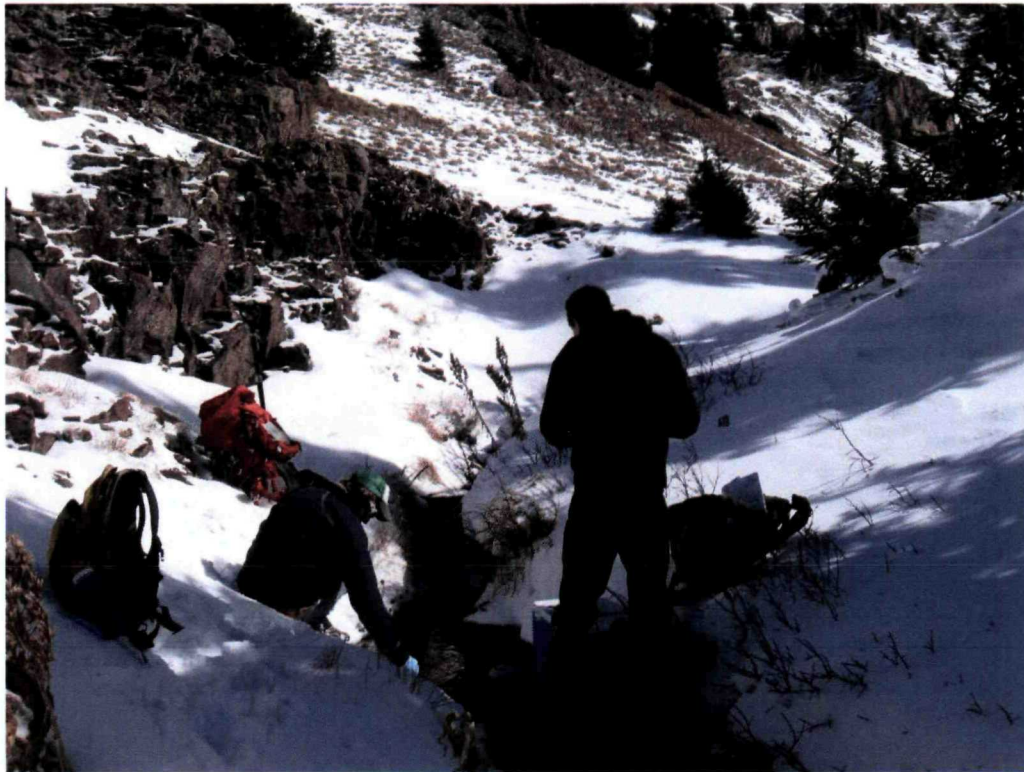
Photo 52
Collection of UASW021 and UASE021 (Cement Creek downstream of Mogul North Mine).

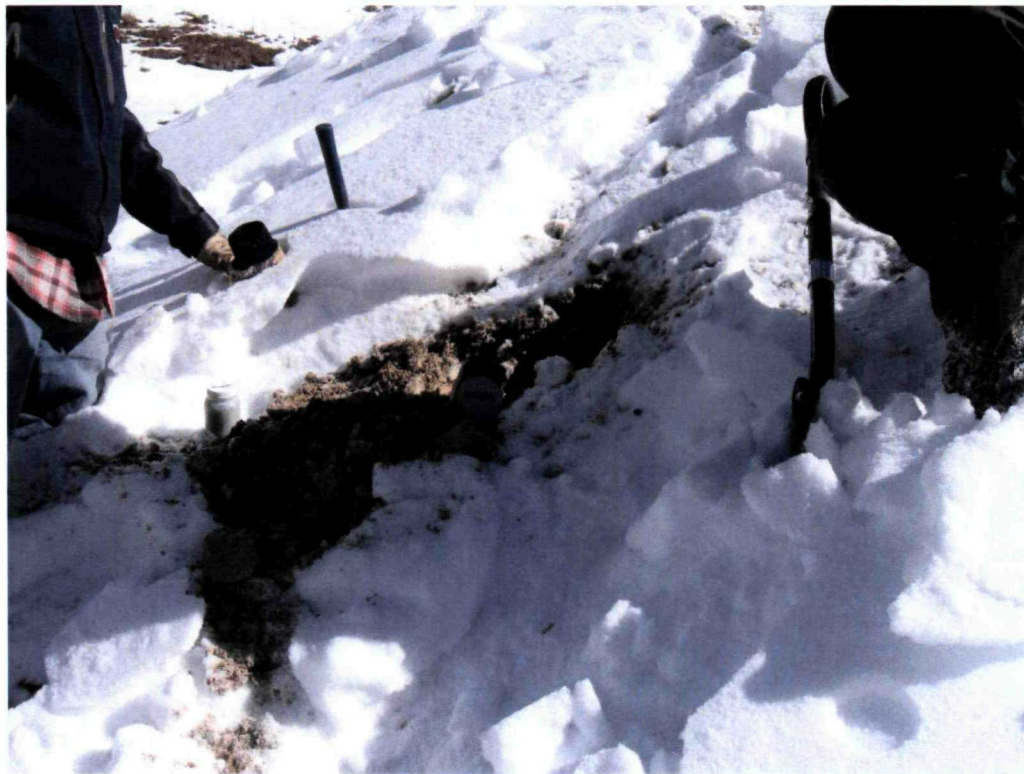
Photo 53
Collection of UASW022 and UASE022 (drainage from of Mogul North Mine).

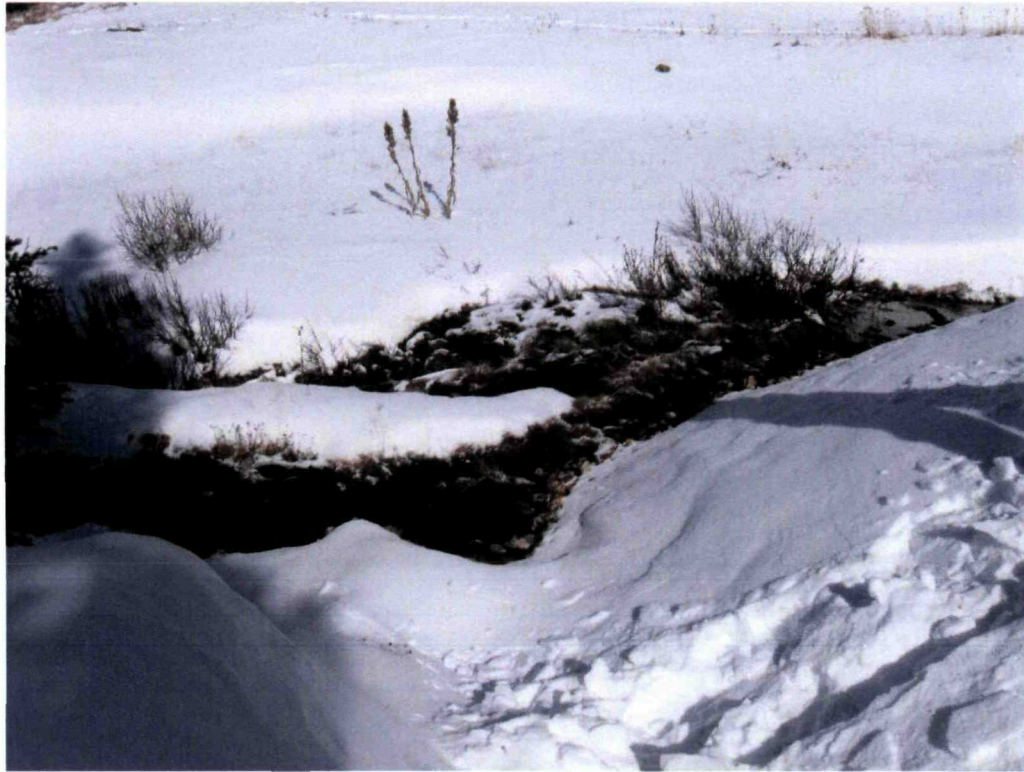
Photo 54
Collection of UASO006 (Mogul North waste pile).

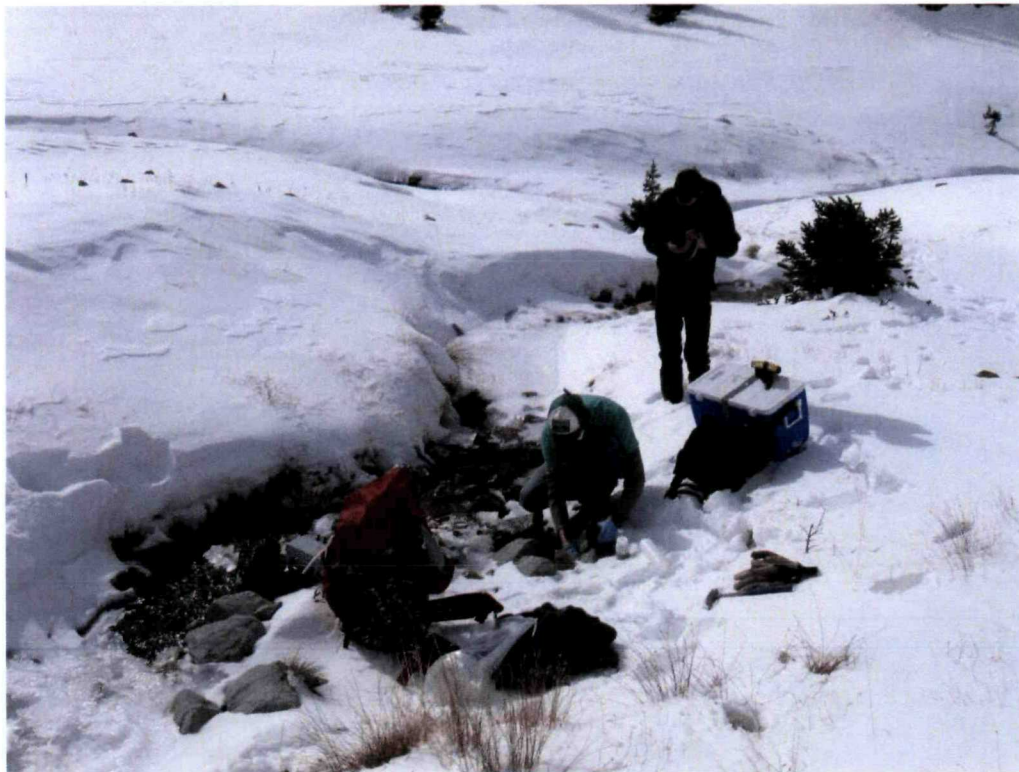
Photo 56
Collection of UASW023 and UASE023 (Cement Creek upstream of Queen Anne Mine).

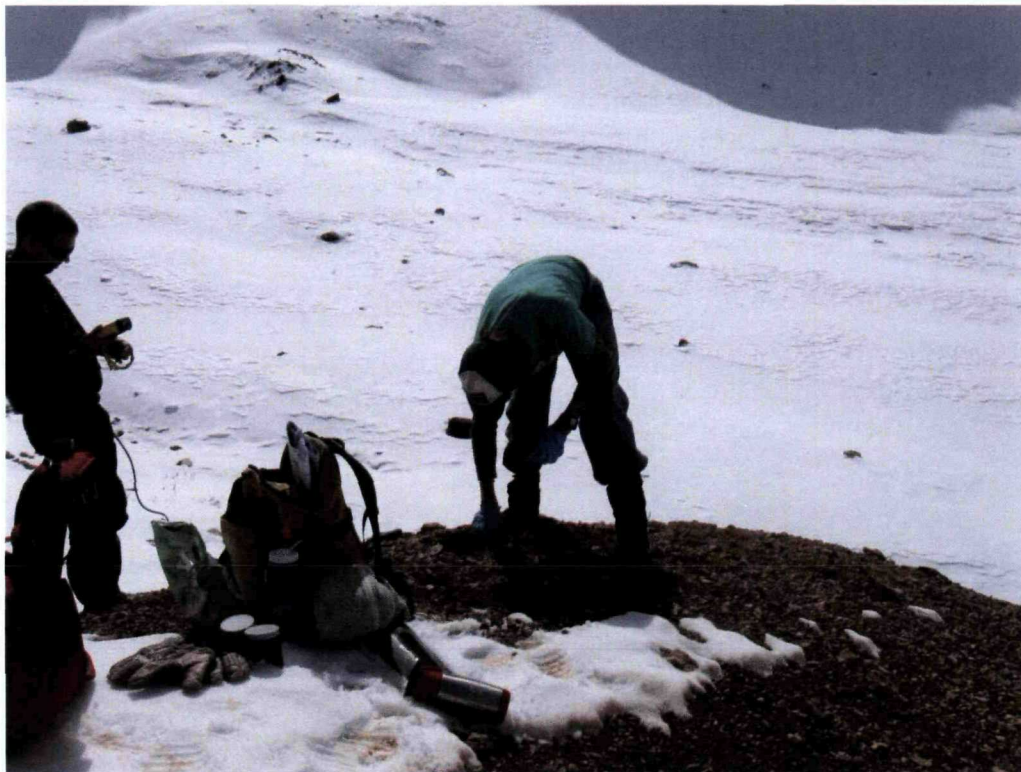
Photo 58
Collection of UASO007 (Grand Mogul Mine stope – west side).

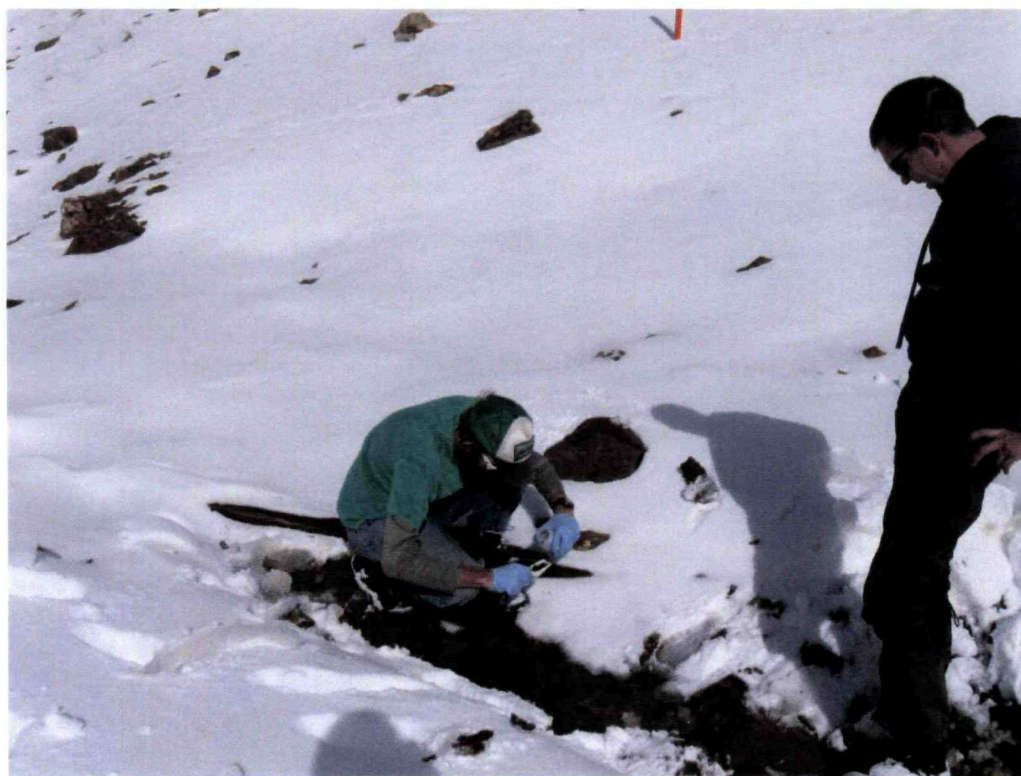
Photo 59
Collection of UASO008 (Grand Mogul Mine stope – east side).

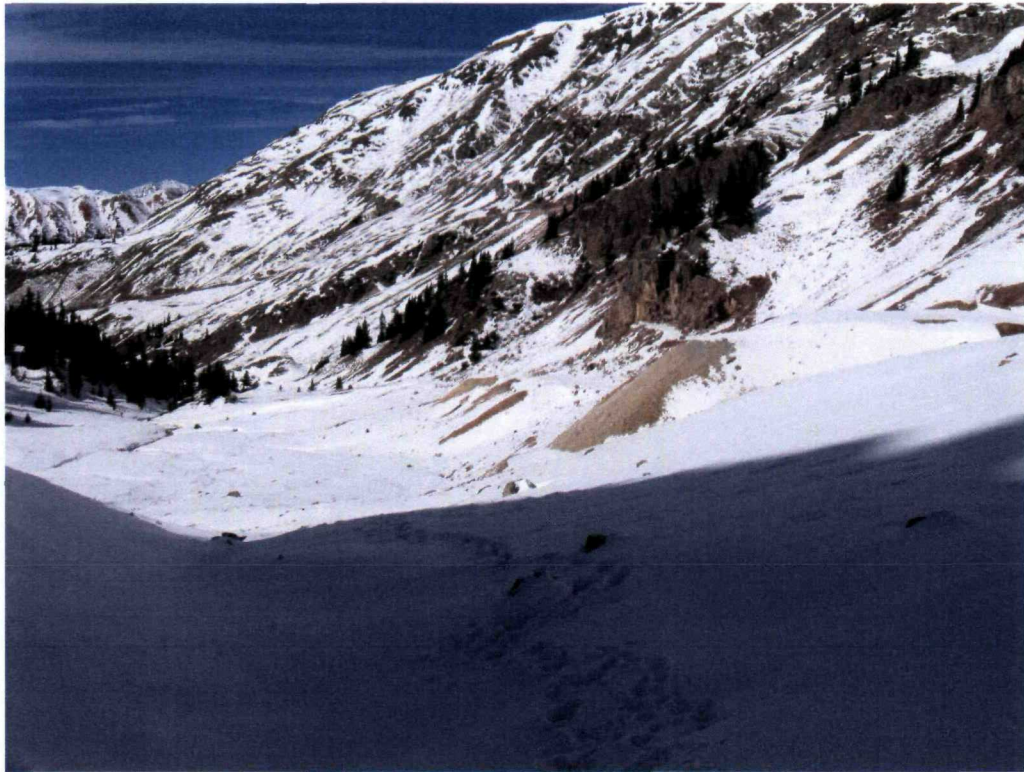
Photo 62
Collection of UASW030 and UASE030 (Cement Creek upstream of Grand Mogul Mine).

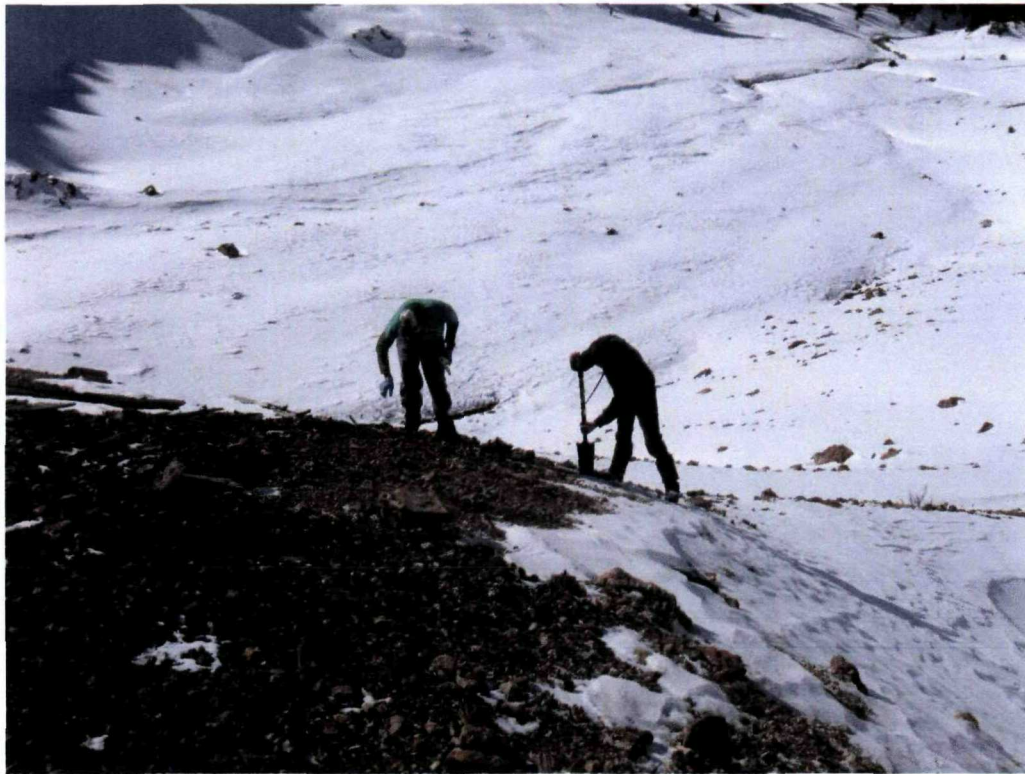
Photo 66
Collection of UASO010 (Grand Mogul Mine waste piles – center).

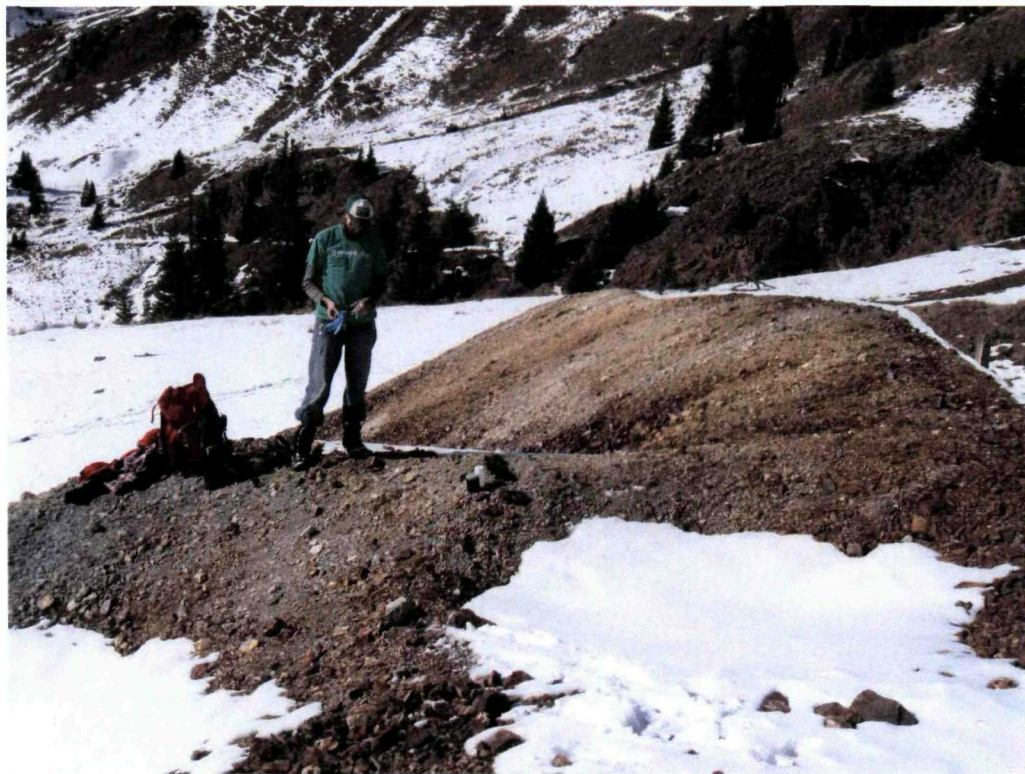
Photo 67
Collection of UASO011 (Grand Mogul Mine waste piles – west side).

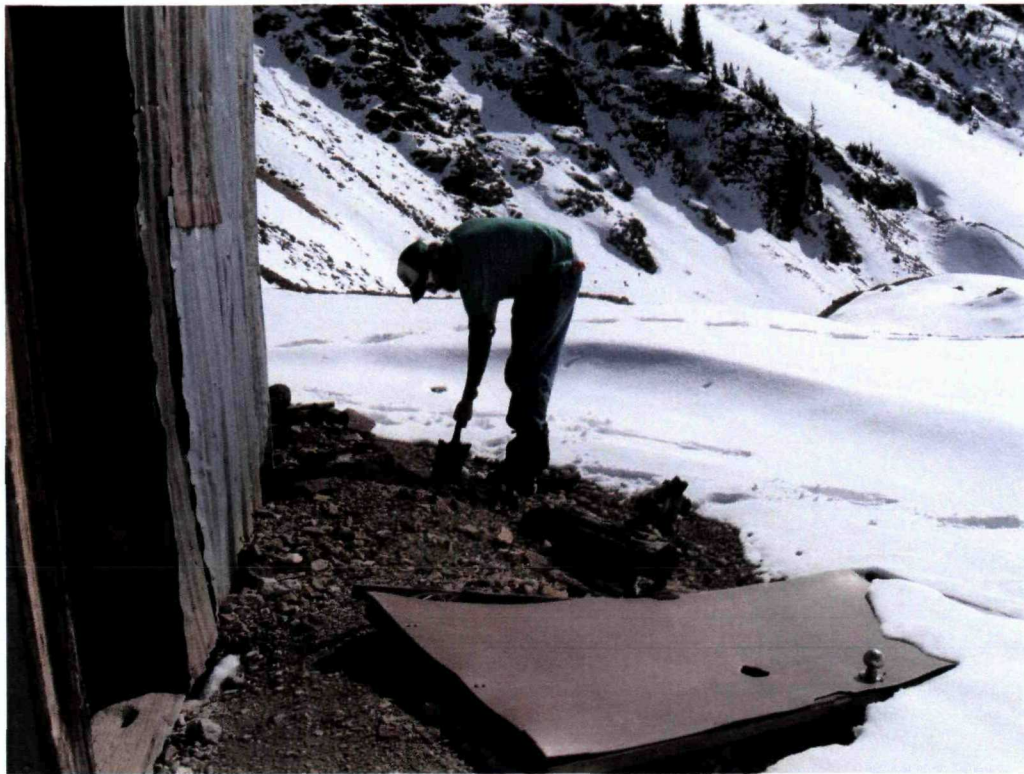
Photo 68
Collection of UASO012 (Mogul Mine waste piles – west side).

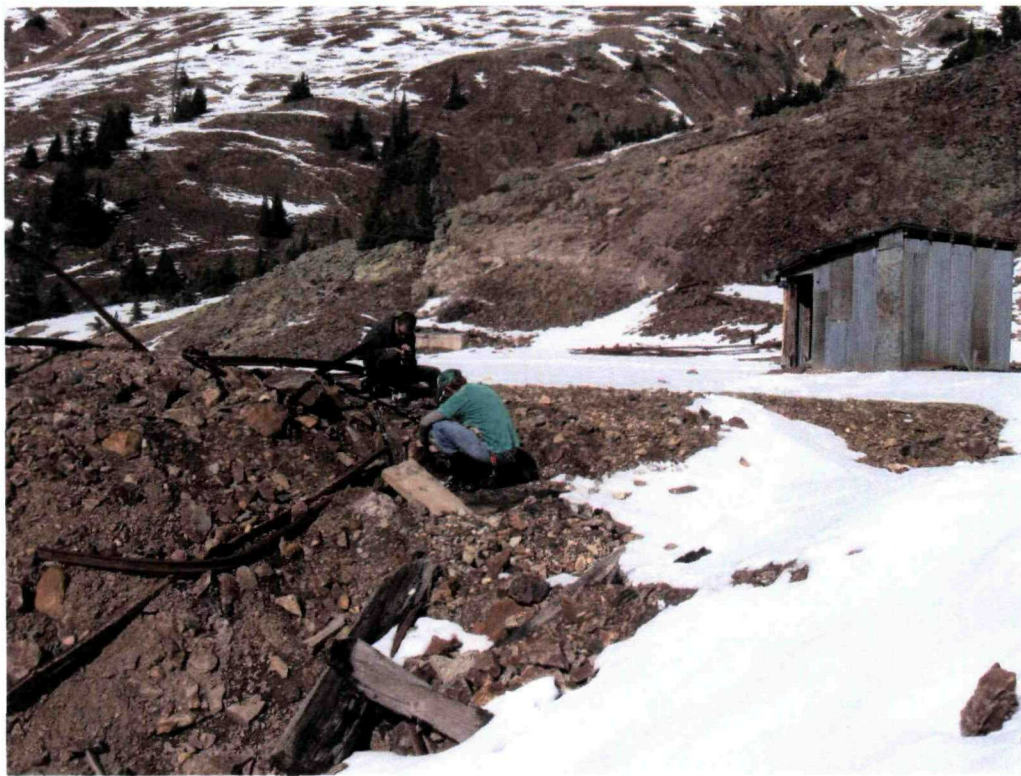
Photo 69

Collection of UASO013 (Mogul Mine waste piles – adjacent to shed).

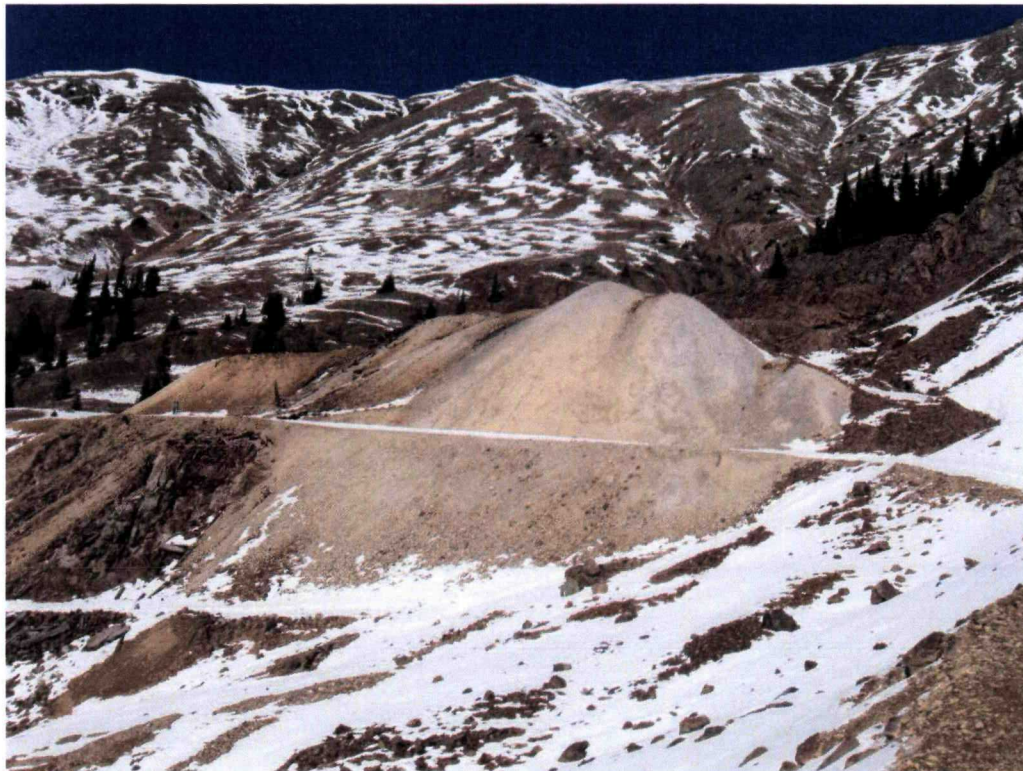
Photo 70

Collection of UASO014 (Mogul Mine waste piles – east side).

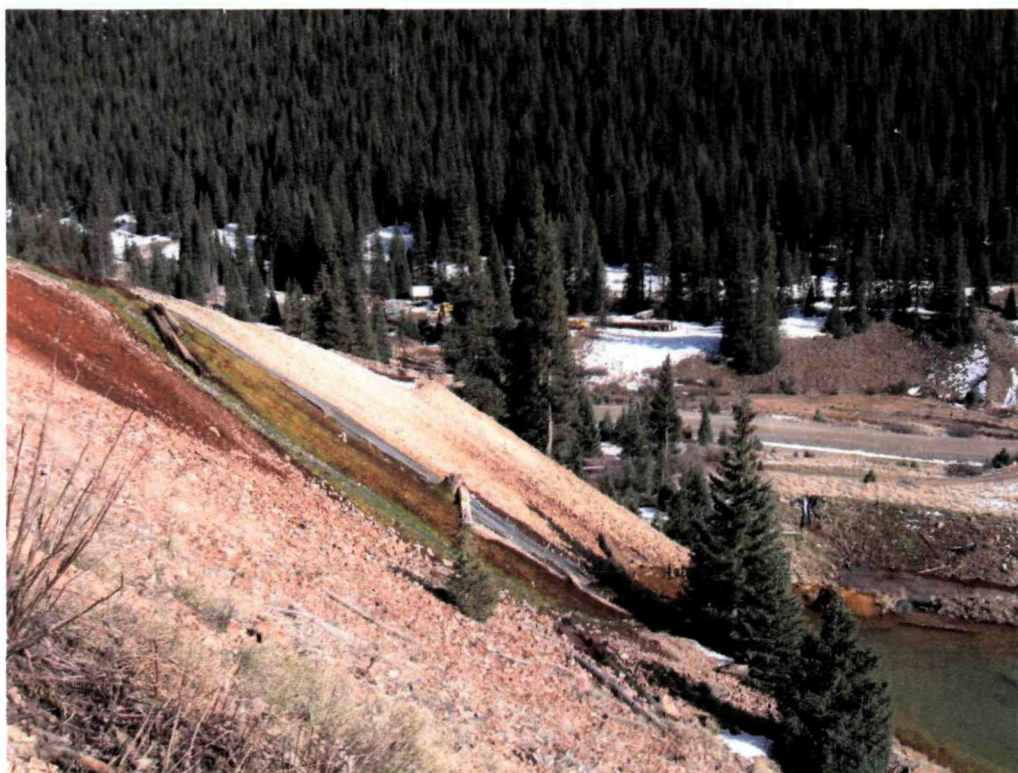
Photo 72
Treatment pond in the vicinity of the Mammoth Tunnel.
